CWA COMPLIANCE EVALUATION INSPECTION REPORT
U.S. ENVIRONMENTAL PROTECTION AGENCY, REGION 5

Compliance Evaluation Sampling Inspection

Ex. 6 Dairy

May 10, 2013

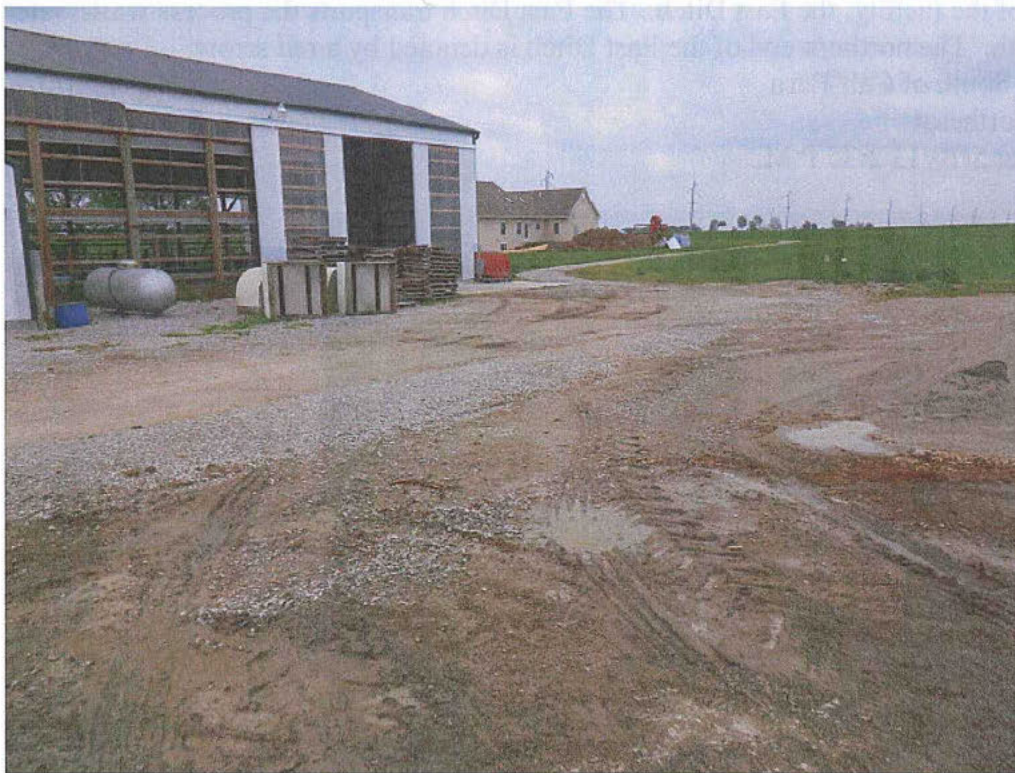
IMGP0080: Calf Barn at northeast corner of the facility. Office is attached to the west side of this building. Rock berm prevents clean water from north from flowing onto the Silage Pad.

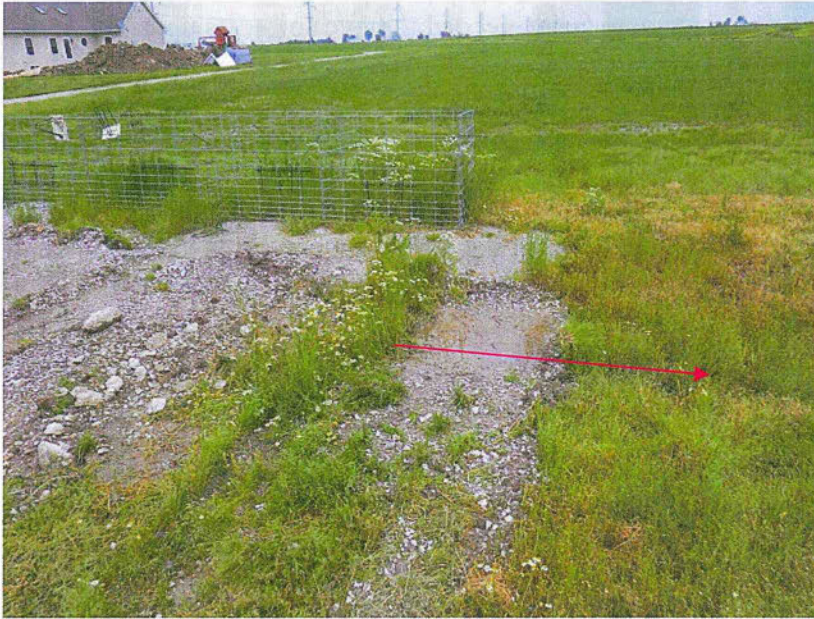
IMGP0081: Surface water from the north end of the silage pad flows to a ditch on the east side of the facility, the East Ditch. The East Ditch transports the process wastewater to the south. The northern end of the East Ditch is denoted by a red arrow.

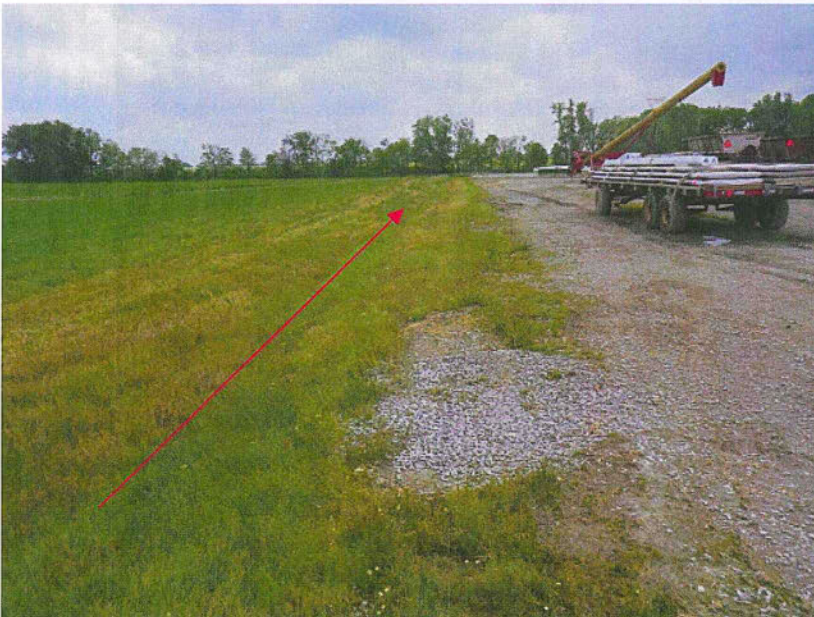
IMGP0082: The East Ditch transports silage leachate and process wastewater to the south. The East Ditch is denoted by a red arrow.

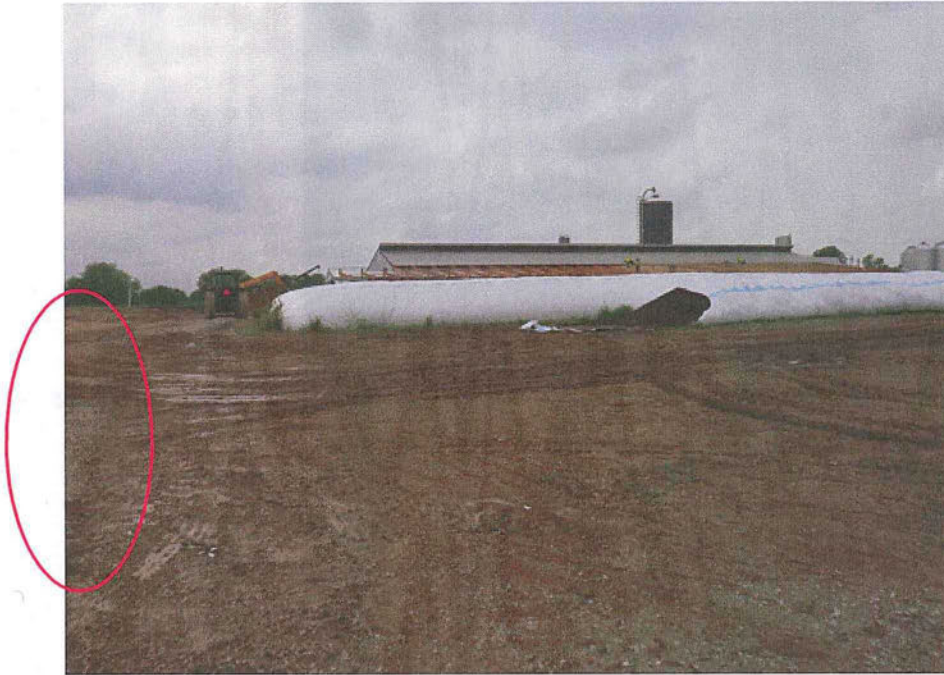
A dirt berm on the southern end of the Silage Pad directed silage leachate and process wastewater to the East Ditch. During the 2012 inspection the East Ditch transported the flow to the intermittent unnamed tributary. As a control of this pollutant, the facility has installed a collection basin to intercept the flow of the East Ditch. A pipe in the collection basin directs the process wastewater to a pump station. Inside the pump station, a pump is triggered by a float and pumps the process wastewater to Holding Pond #1.

IMGP0083: South end of silage bags on silage pad. Berm on south end directs process wastewater to the east and to the East Ditch. Berm location is denoted by a red oval.

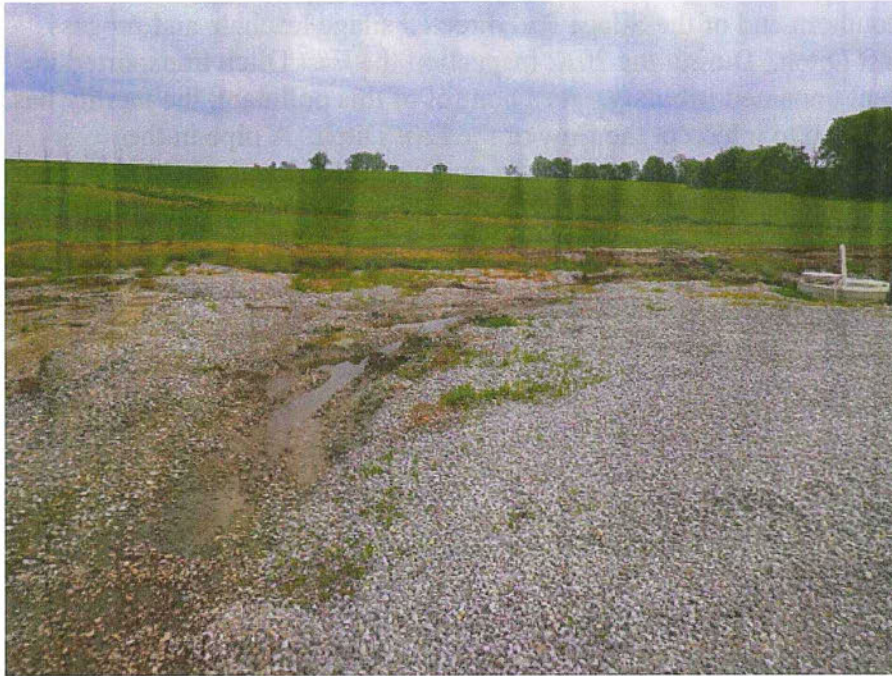
IMGP0084: Flow of process wastewater from silage bags to the east. Flow is directed the East Ditch and then to a collection basin.

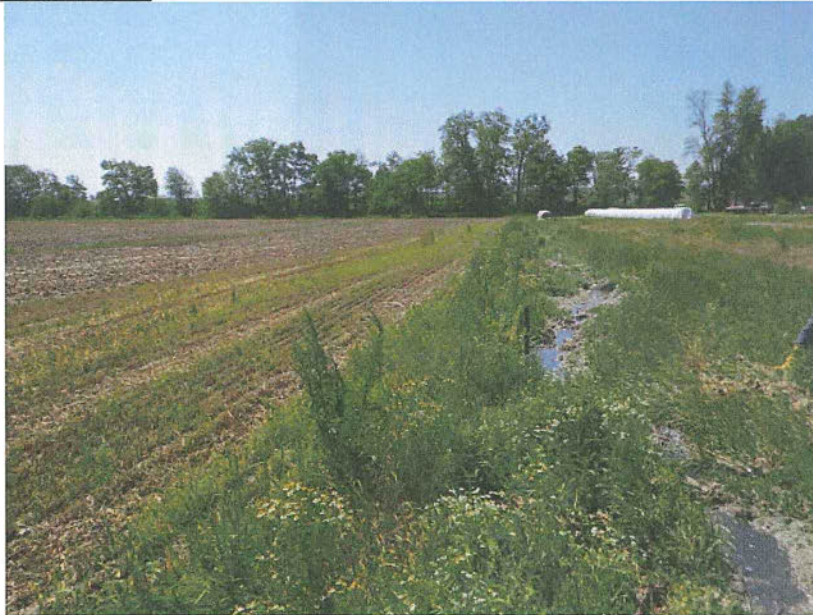
2012 Photo

IMGP0496: East Ditch flows to the south. An intermittent unnamed tributary of Lake Branch lies in the tree line.

1. From the silage bags on the east side of the facility, to a ditch which EPA will identify as the East Ditch, and then to the intermittent unnamed tributary of Lake Branch.

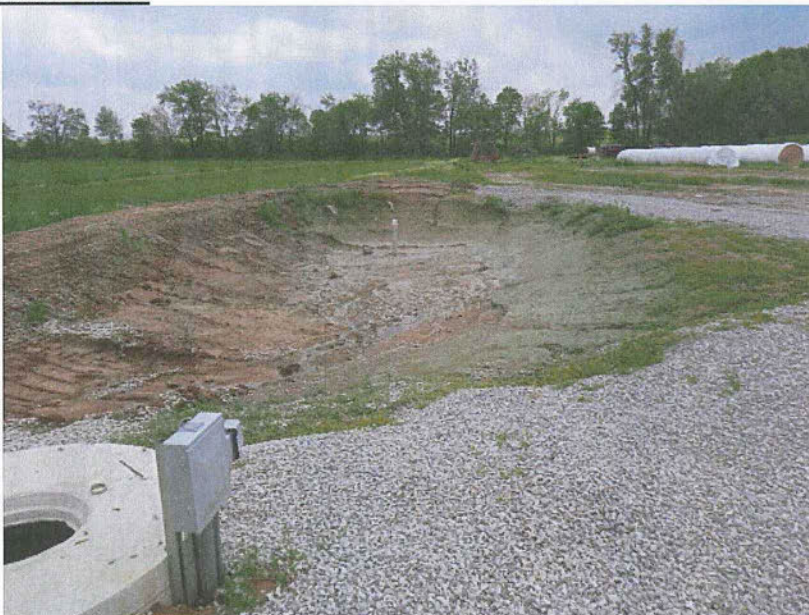
2013 Photo

IMGP0085: Collection basin for silage leachate and process wastewater. The process wastewater flows to a pipe which gravity feeds to the pump station.

1. Installing a collection basin and pump station that collects the silage leachate and process wastewater and pumps it to Holding Pond #1.
2. Removing the pipe outlet to the intermittent unnamed tributary from the Clean Water Pond and installing:

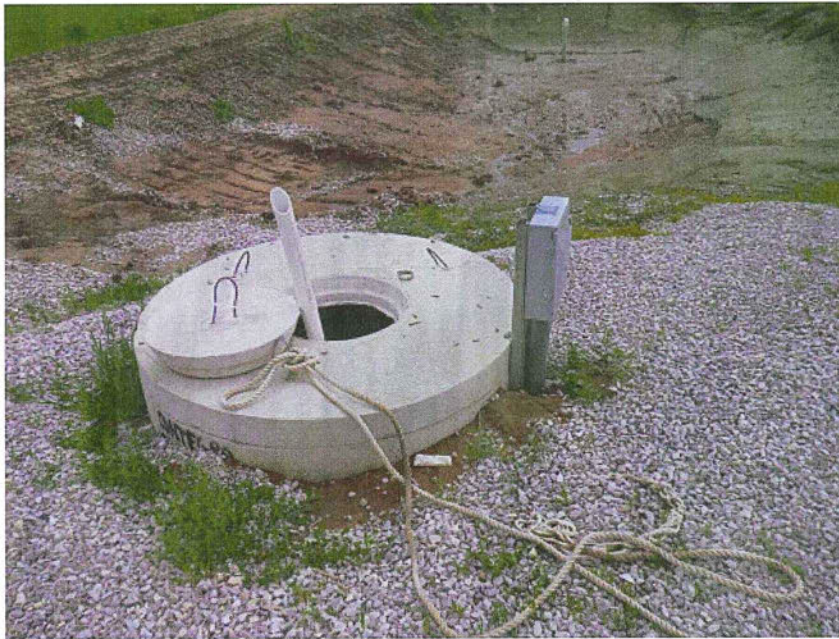
IMGP0086: Pump station that holds a pump which pumps the process wastewater to Holding Pond #1.

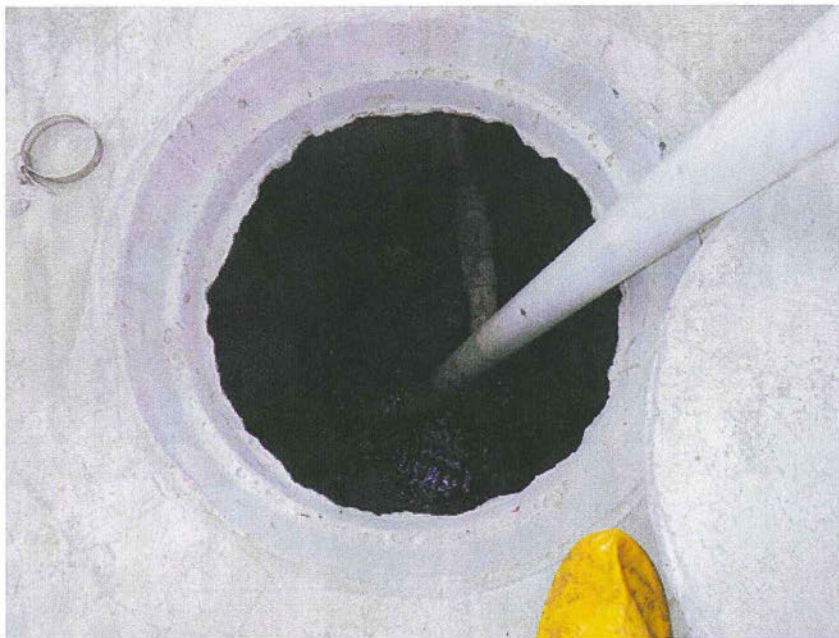
IMGP0087: Pump station for process wastewater from the silage leachate collection basin.

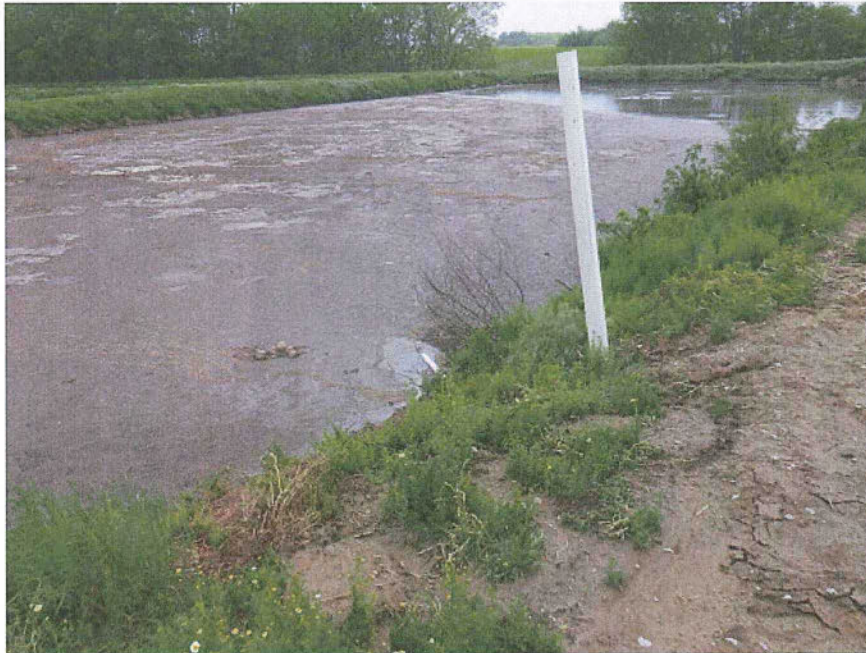
IMGP0088: Outlet pipe into Holding Pond #1 from pump for silage leachate.
 Location: Northeast corner of Holding Pond #1
 Facing: Southwest
 Date/Time: 5/10/13 2:40 P.M.

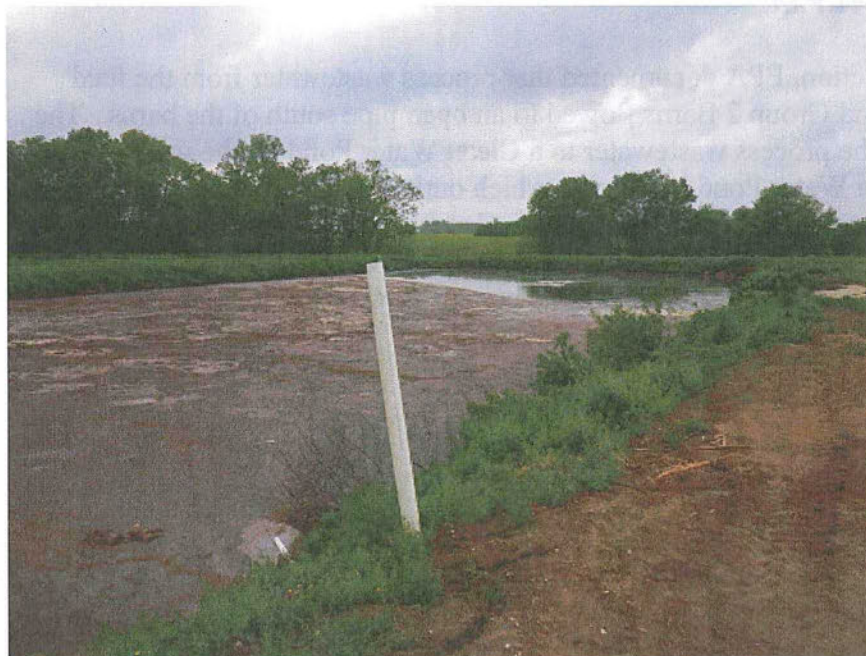
IMGP0089: Berms are well maintained on Holding Pond #1. Holding Pond #1 overflows to Holding Pond #2.
 Location: Northeast corner of Holding Pond #1
 Facing: Southwest
 Date/Time: 5/10/13 2:41 P.M.

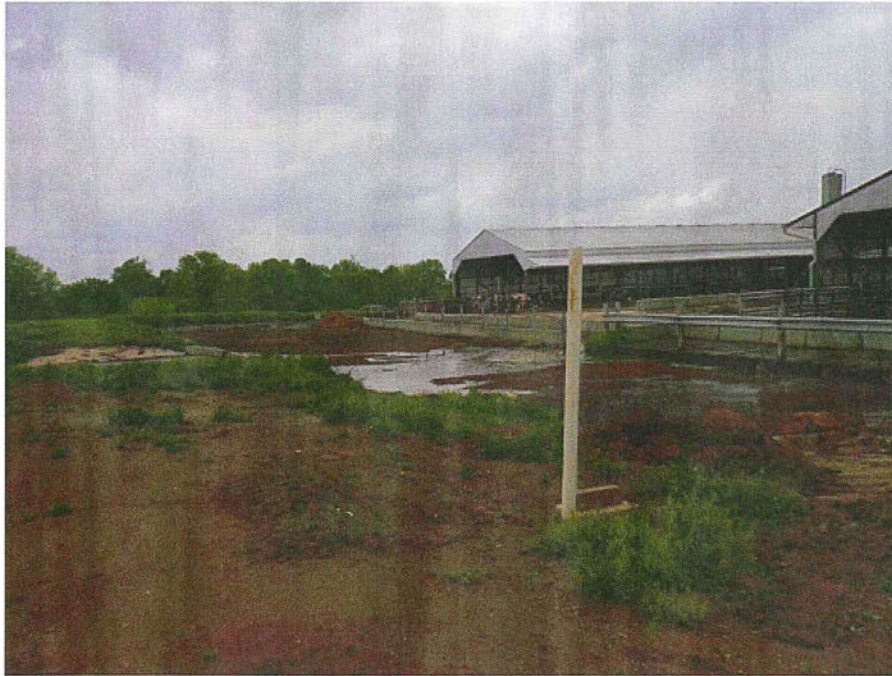
IMGP0090: Settling Basin for manure from the Freestall Barns. Liquid from the Settling Basin overflows to Holding Pond #1.

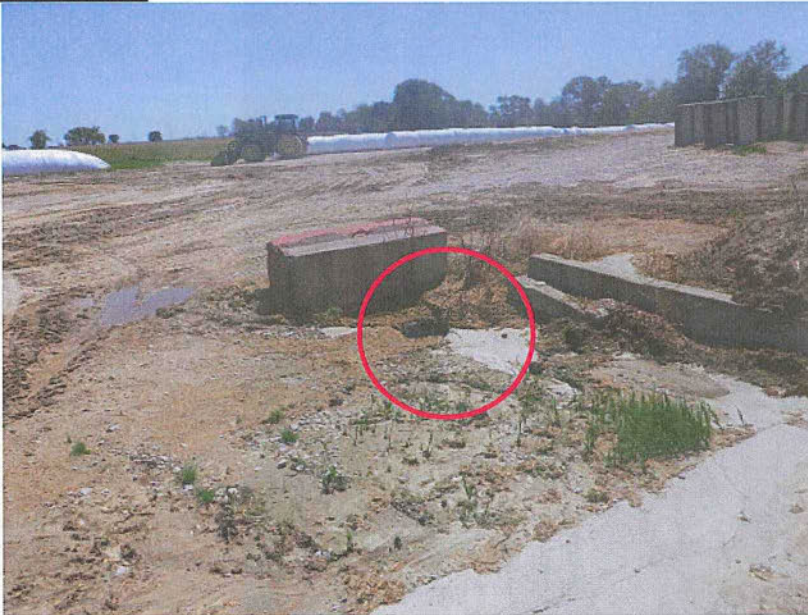
2012 Photo

IMGP0567: Open pipe south of Group 1 and Group 2 Barn (circled with red circle).

- e. From the open pipe in the ground on the east side of the facility to the pond at the end of the Grassed Filter Strip and then to the intermittent unnamed tributary.

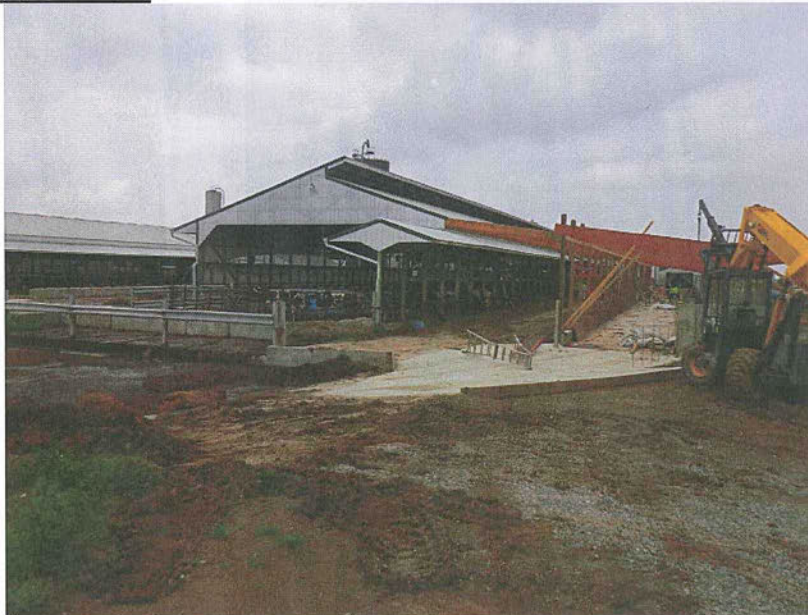
2013 Photo

IMGP0091: During previous inspection, process wastewater flowed from the feed alley on the east side of the Group 1 and Group 2 Barns to an open pipe to the south. During construction to expand the barns the manhole has been removed.

- e. Removing the open pipe in the ground south of the Group 2 Barn and covering the feed alley for the Group 1 and 2 Barns.

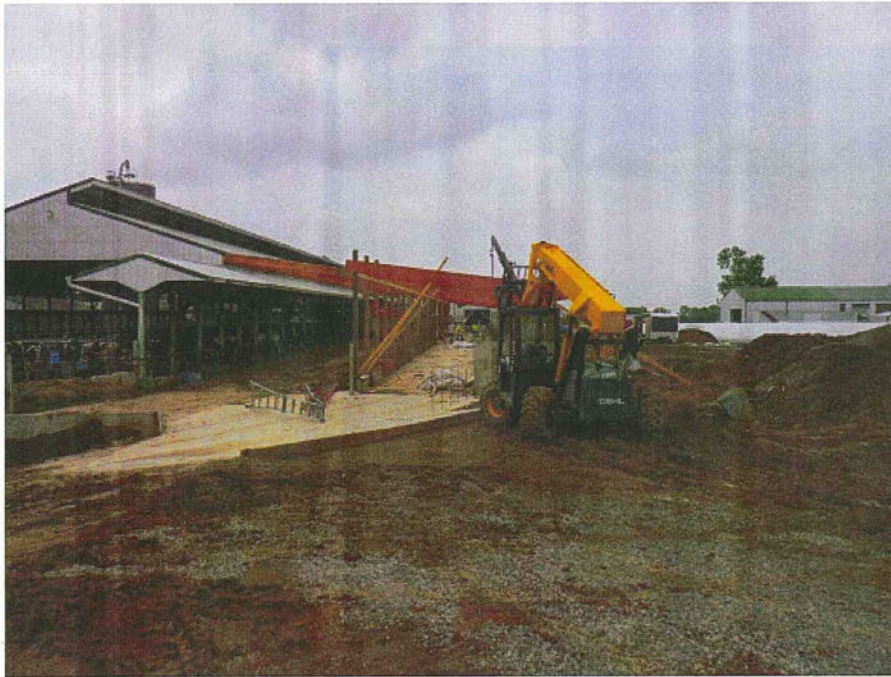
IMGP0092: Construction on the Group 1 and Group 2 Barns.

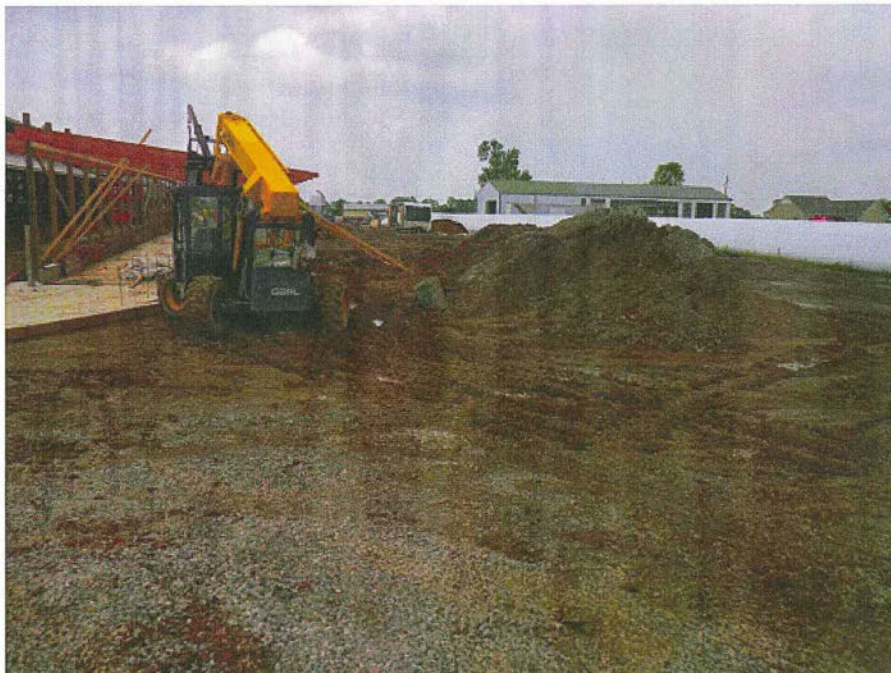
IMGP0093: Construction on the Group 1 and Group 2 Barns.

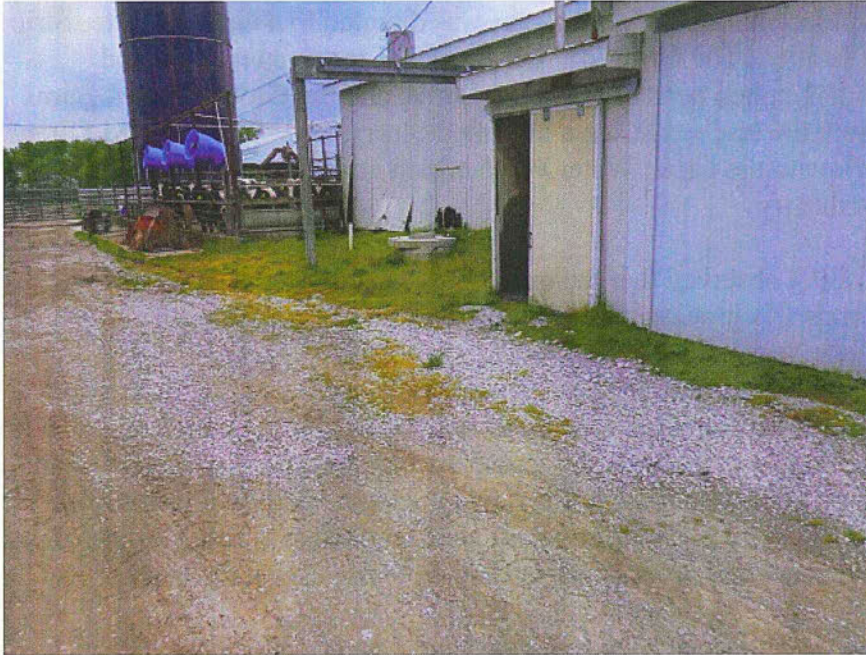
During this inspection, EPA observed that the milk house wash water now flows to a pump station which pumps this process wastewater to Holding Pond #1.

IMGP0094: Milk house wash water, which previously was directed to the Grassed Filter Strip, is now collected in a pit and pumped to Holding Pond #1.

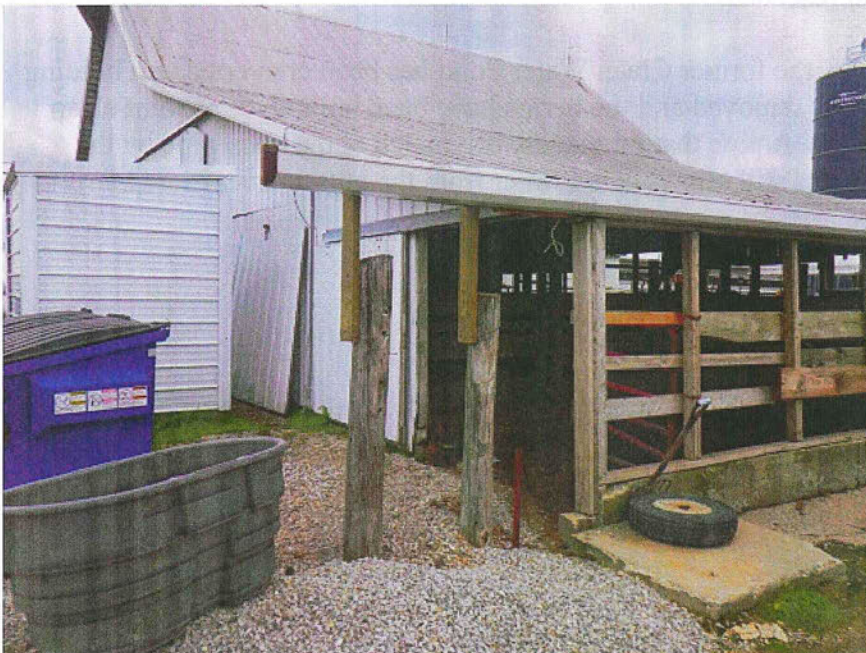
IMGP0095: Downspouts for gutters are on the plan for future improvements.

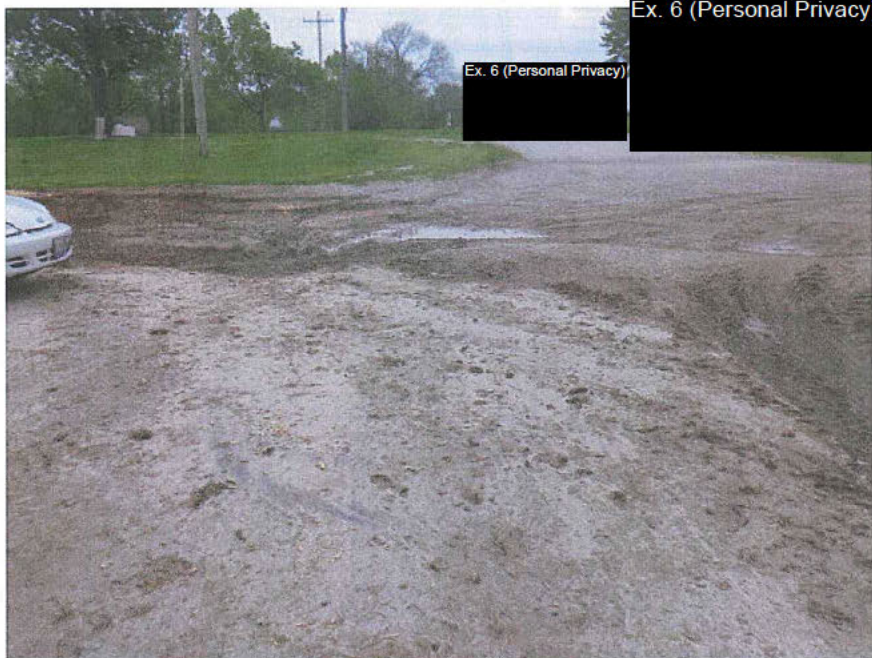
IMGP0096: Dirt berm in driveway prevents clean storm water from flowing through open pens by Hoop Barns.

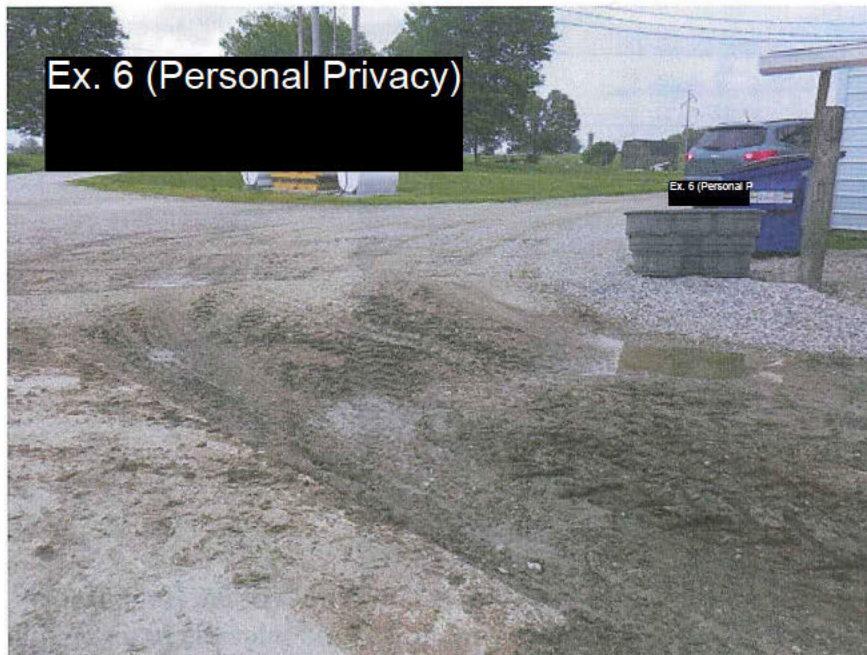
IMGP0097: Dirt berm in driveway prevents clean storm water from flowing to the west.

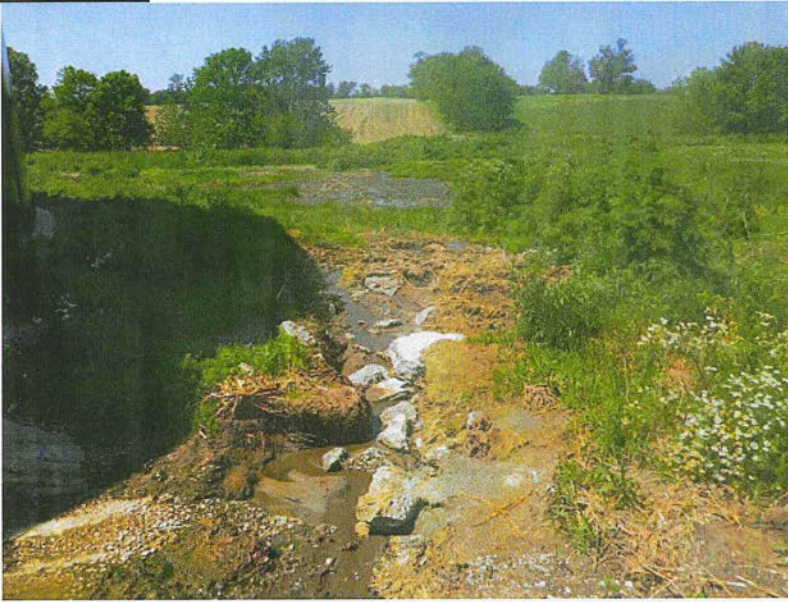
2012 Photo

IMGP0559: Flow pathway from Hoop Barns and Slurrystore to the Grassed Filter Strip.

- c. From the Hoop Barns to the Grassed Filter Strip on the west side of the facility, and then to pond at the end of the Grassed Filter Strip and then to the intermittent unnamed tributary.

- d. From the open wall of the Slurrystore to the Grassed Filter Strip on the west side of the facility, and then to pond at the end of the Grassed Filter Strip and then to the intermittent unnamed tributary.

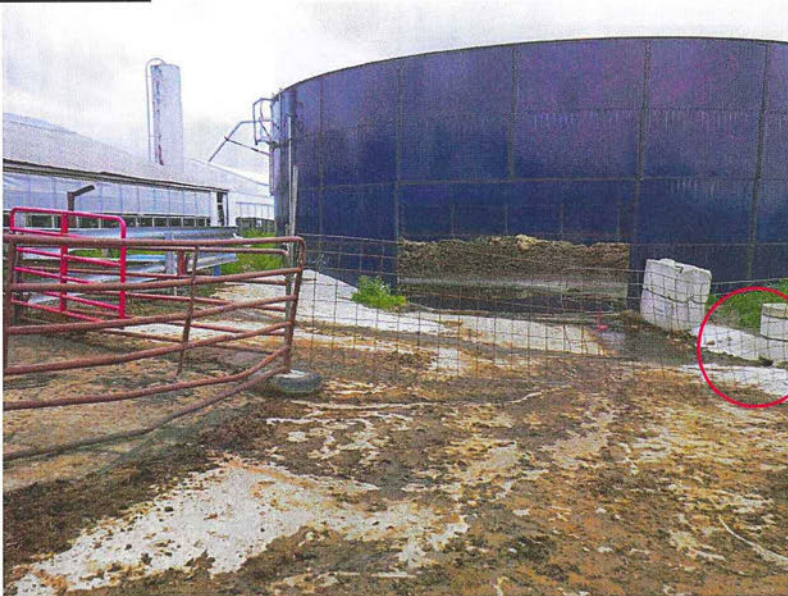
2013 Photo

IMGP0098: The manure and process wastewater from the open pens of the Hoop Barns and the manure stacked inside the modified Slurrystore flows to an inlet where piping allows it to flow by gravity to Holding Pond #4, the former Clean Water Pond. Inlet location is denoted by a red circle.

- c. An inlet and piping to collect the manure and process wastewater from the Hoop Barns and their open pens and allowing it to gravity flow to Holding Pond #4.

- d. An inlet and piping to collect the manure and process wastewater from the manure stacked in the Slurrystore and allowing it to gravity flow to Holding Pond #4.

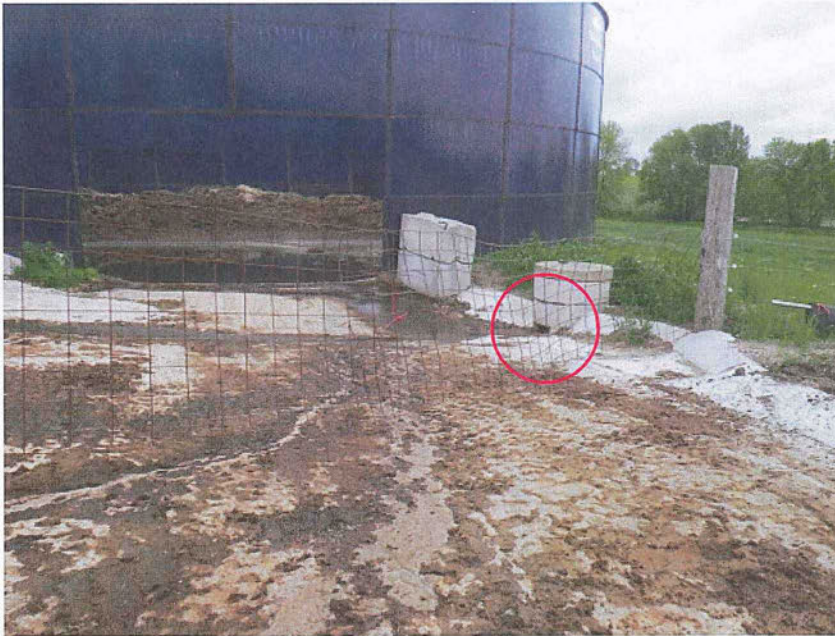
IMGP0099: Pipe inlet for manure and process wastewater is denoted by a red circle.

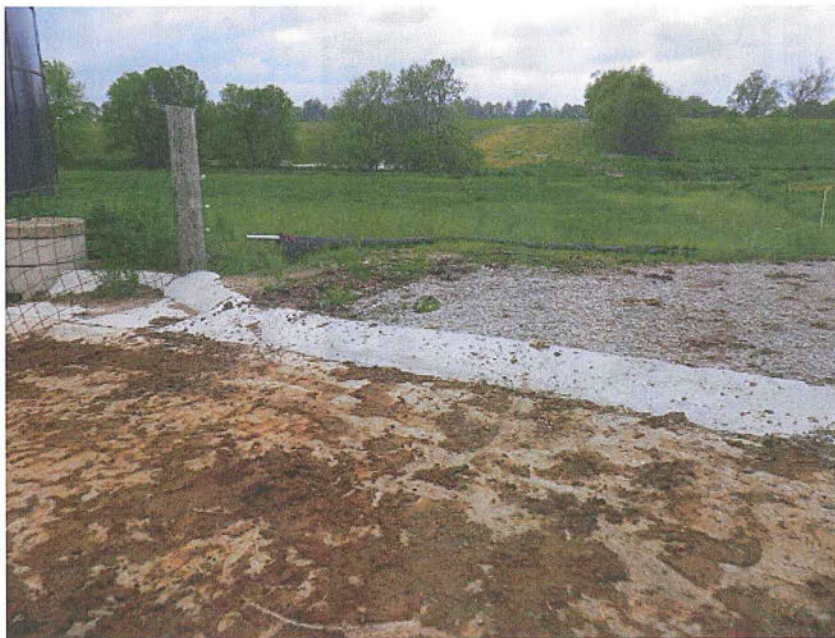
IMGP0100: Mountable concrete curbing has been installed around the open pens to divert the manure and process wastewater to the pipe inlet. Former Grassed Filter Strip is in background.

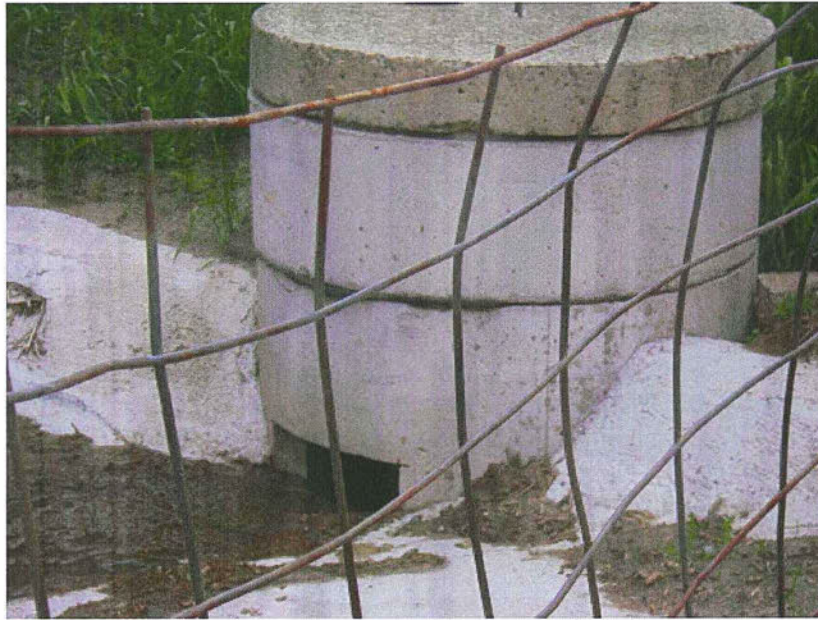
IMGP0101: Pipe inlet structure. Manure and process wastewater are piped to Holding Pond #4.

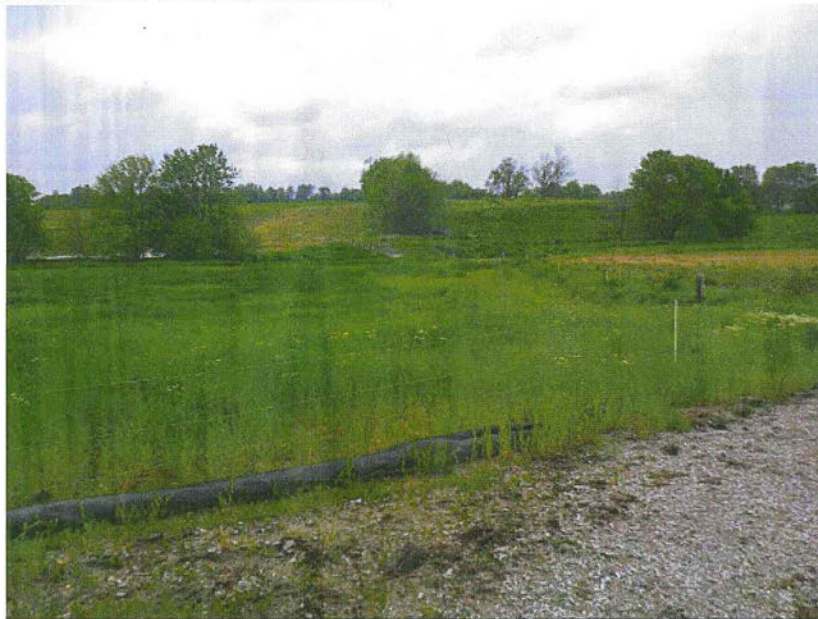
The former Grassed Filter Strip was scraped clean and several inches of soil removed. All vegetation and soil was land applied. The area where the Grassed Filter Strip was located was leveled and reseeded.

IMGP0102: Former location of the Grassed Filter Strip. Mr. Dall removed and land applied the vegetation and soil. This area has been leveled and reseeded. No manure or process wastewater flows through it and storm water flow from this area goes directly to the intermittent unnamed tributary.

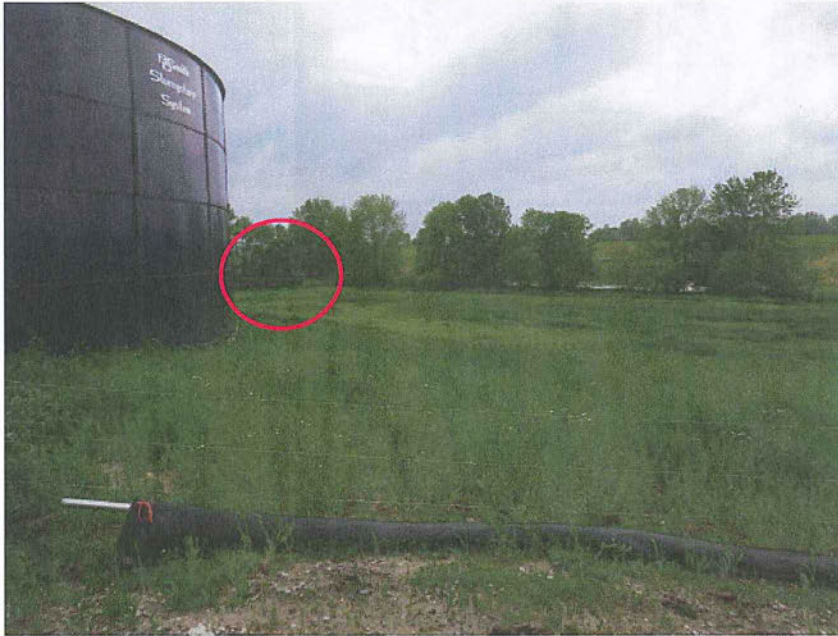
IMGP0103: Former Grassed Filter Strip. Location of Holding Pond #4 is denoted by a red circle.

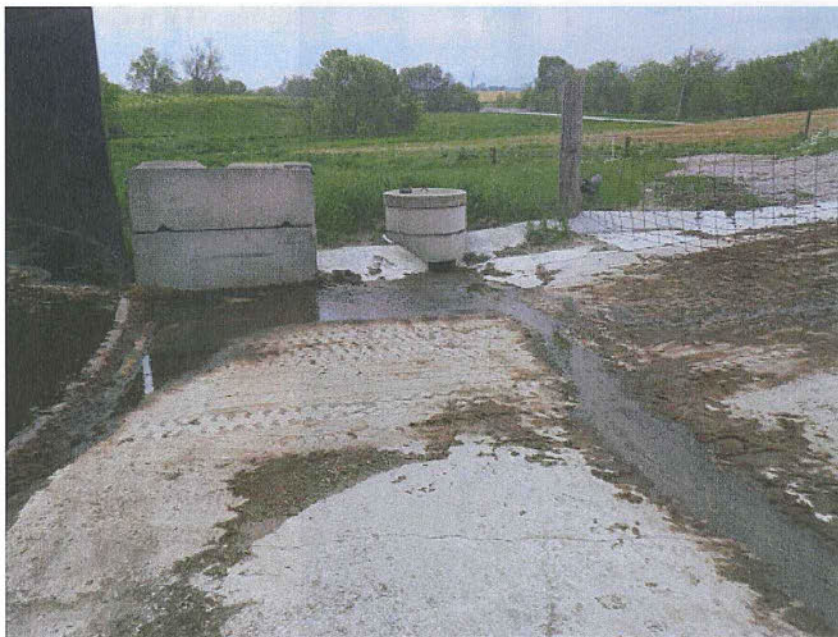
IMGP0104: Flow of manure and process wastewater from the open pens and the manure storage in the Slurrystore.

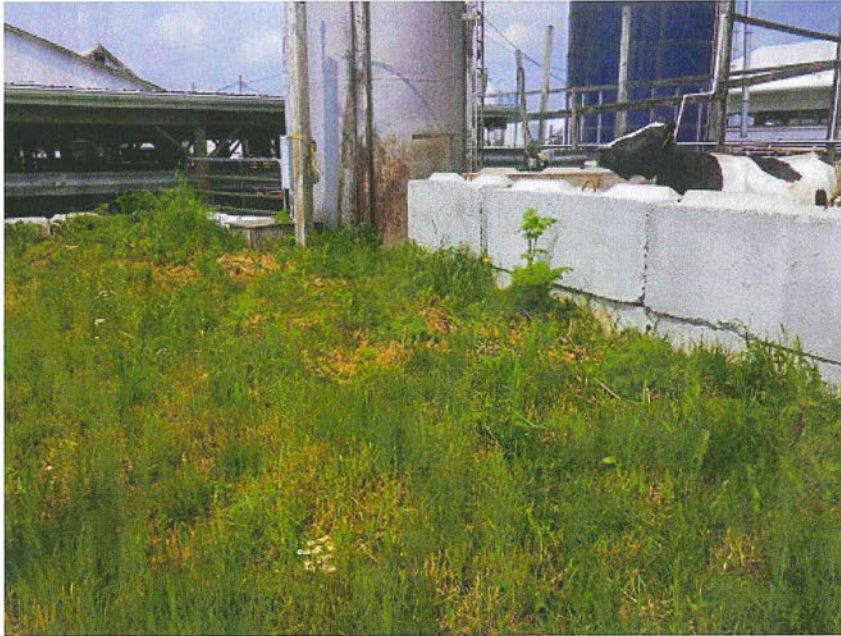
IMGP0105: The open pen on the north side of the Group 4 Barn has been contained with concrete blocks and the berm outside the blocks prevents the manure and process wastewater from flowing to the yard to the west.

- a. A concrete block wall and dirt berm around the open pen of the Group 4 Barn to contain the manure and process wastewater from leaving the pen on the west side.

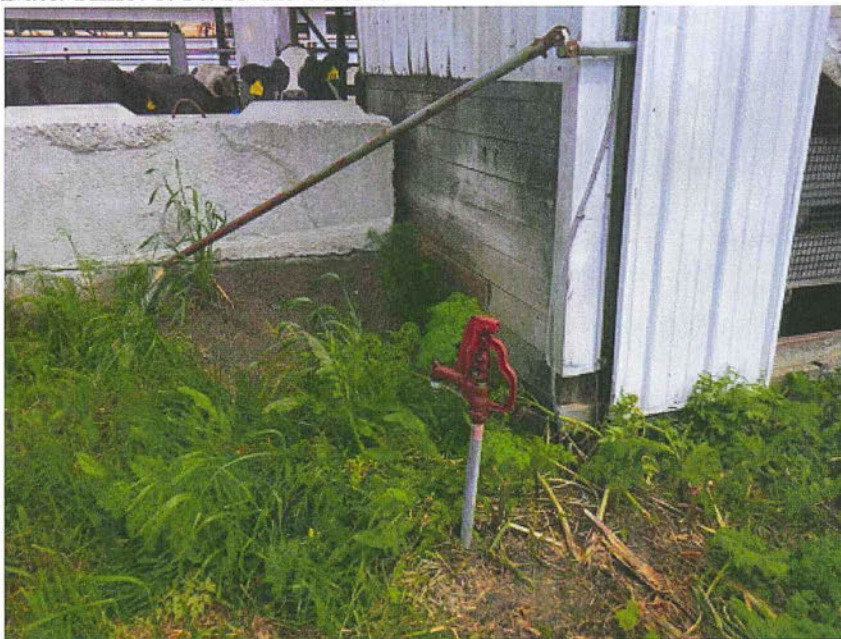
IMGP0106: Northwest corner of Group 4 Barn has been modified so manure and process wastewater do not discharge to the yard to the west.

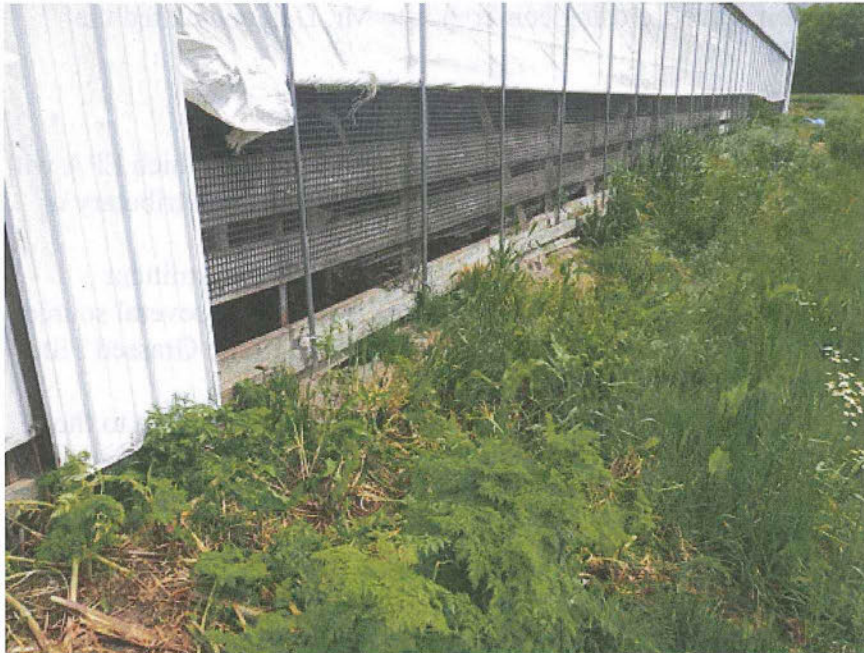
IMGP0107: Looking south along the west wall of the Group 4 Barn.
 Location: Northwest corner of Group 4 Barn
 Facing: southeast
 Date/Time: 5/10/13 2:55 P.M.

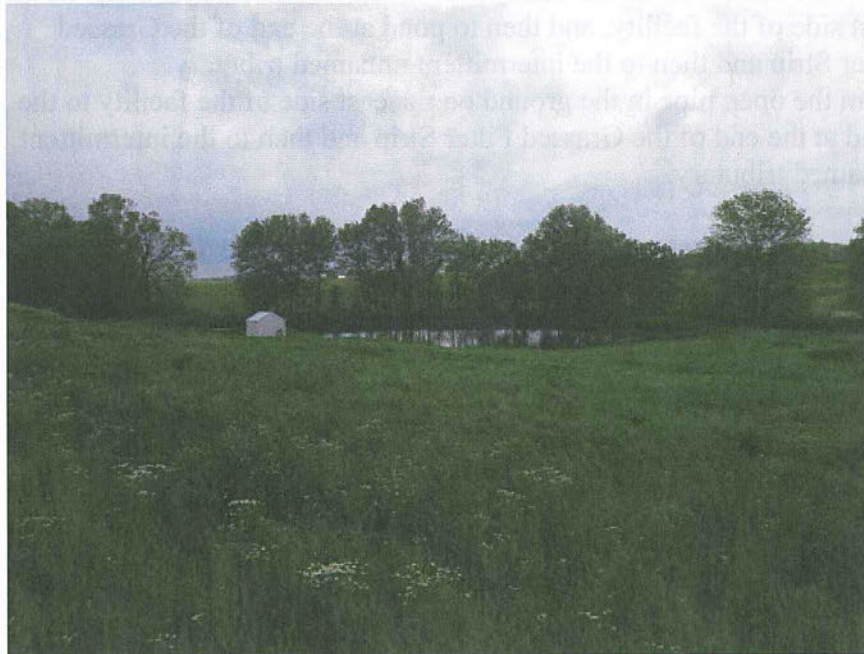
As mentioned previously, the former Clean Water Pond has been converted to a holding pond. The outlet pipe was removed and the berms have been built up to prevent clean water from flowing into it. A pipe that previously originated at the open pipe by the Group 1 and Group 2 Barns still allows clean water from the gutters over these barns to outlet in the pond.

IMGP0108: Formerly the Clean Water Pond, this is now Holding Pond #4. Berms around the sides prevent clean water from the west yard to flow into it. The pipe from the pond to the intermittent unnamed tributary has been removed.
 Location: West of Group 4 Barn
 Facing: Southwest
 Date/Time: 5/10/13 3:03 P.M.
